CRITICAL EVALUATION OF THE MOTOROLA M12+ GPS TIMING RECEIVER VS. THE MASTER CLOCK AT THE UNITED STATES NAVAL OBSERVATORY, WASHINGTON, DC

Abstract

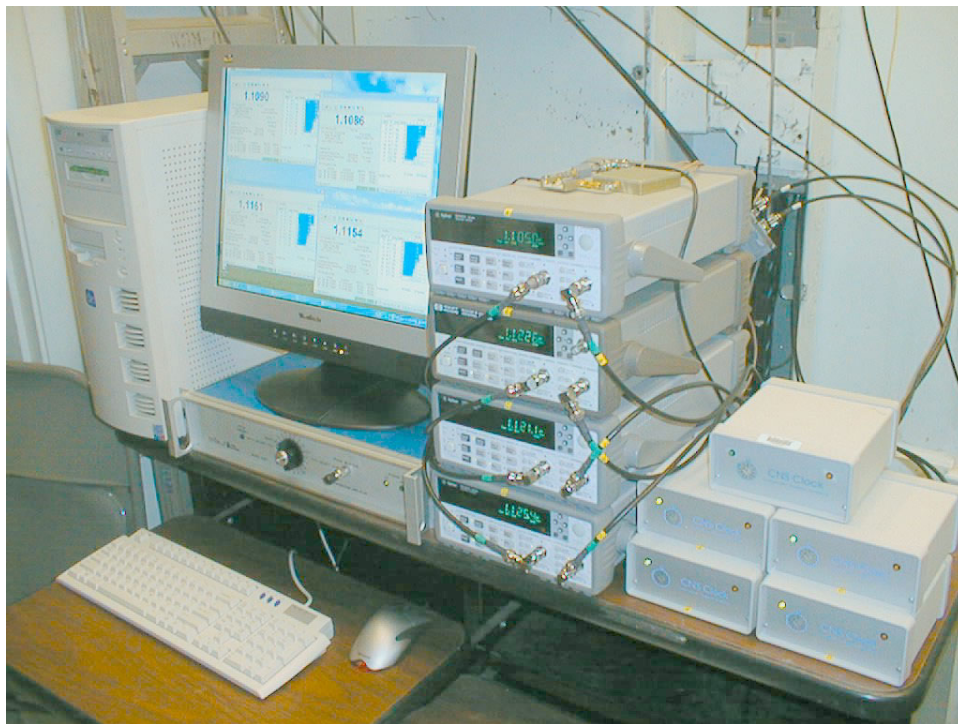
Figure 1. The CNS test bed.

bed is sized to simultaneously test four receivers. The architecture is an extension of the Master Clock monitoring facility developed for NASA's Very Long Baseline Interferometry (VLBI) geophysical observatory sites around the world. It is based on the use of a time interval counter (TIC) coupled with a computer that controls the GPS receiver module and performs data collection, reduction, statistical computations, and logging.

The Test Bed can be seen in Figure 1. Data collection was anticipated to be about 10 Mb per day. The computer also simultaneously collects data from four TICs and interfaces with four GPS receivers using eight serial ports. This requires a high-performance personal computer with plenty of disk storage, eight high performance serial ports, and fast enough to run four copies of the Tac32Plus software and respond quickly to many interrupts.

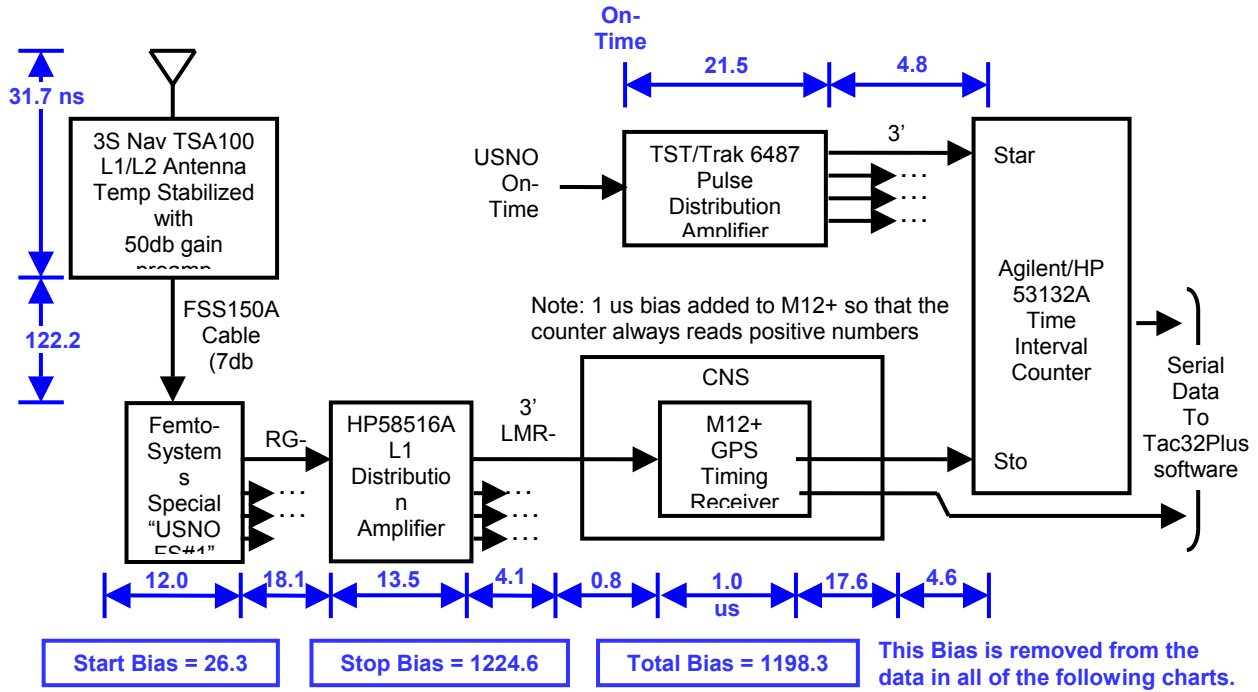
Figure 2. Test bed calibration.

Short cables with connectors were calibrated using an Agilent 8595E spectrum analyzer with tracking generator and an assortment of directional couplers by observing the unterminated cable's effect on a resonant circuit.

Longer cables and the 1PPS distribution amplifier were measured by feeding a 1PPS signal from a USNO hydrogen maser through the cable and observing the delay on an Agilent 53132A time interval counter, while maintaining correct termination impedance. Ed Powers of USNO assisted with these tests.

The GPS antenna, main cable, and USNO's distribution amplifier had previously been calibrated by USNO staff using an HP 8719D (13.6 GHz) network analyzer. Ed Powers of USNO calibrated the additional L1 signal splitter using this same network analyzer.

The final results were carefully reviewed with the assistance of Ed Powers and are shown in Figure 2.

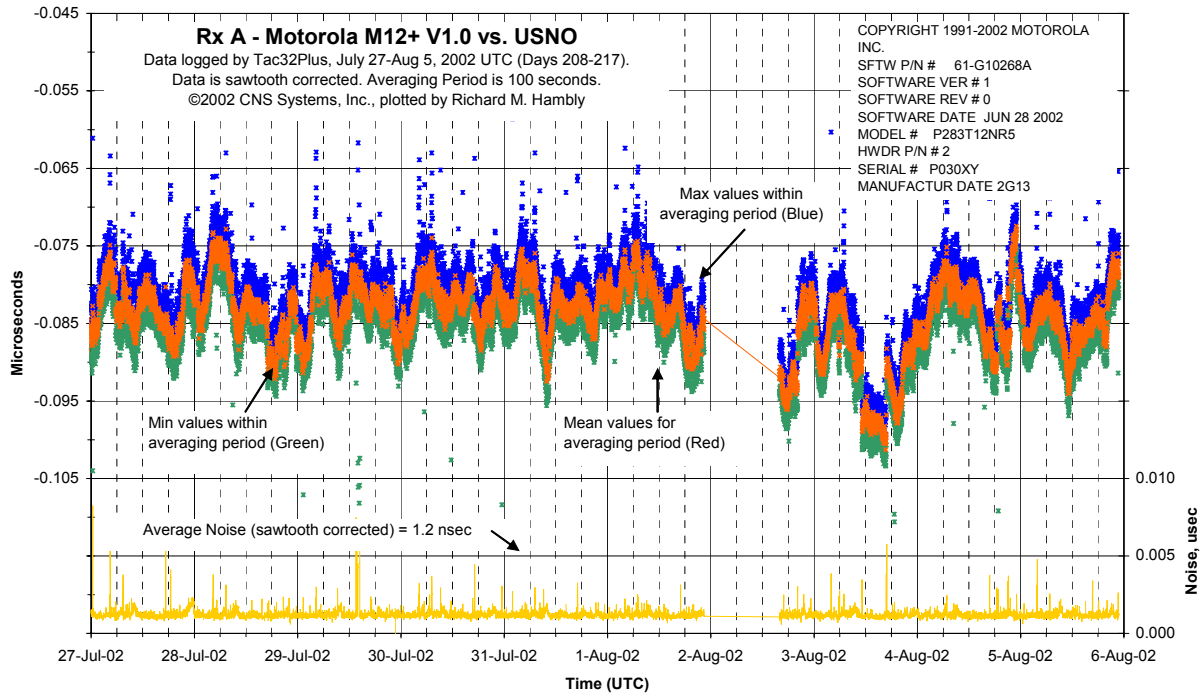
Figure 3. Pre-calibration results.

The four Motorola M12+ receivers were tested and evaluated against UTC, accounting for the calibration offsets in the Test Bed. A sample of the pre-calibration results is shown in Figure 3. The missing data from late on 1 August (UTC) through mid-day on 2 August was due to a power failure at USNO. After this happened two more times, we realized that this was the peak time of year for lightning, so we changed the power source to run off fully protected and backed up power. Fortunately, there was no damage to any of the equipment.

The receivers were all found to perform similarly with their 1PPS signals each about 84 nanoseconds early. Receiver-to-receiver tracking was very good, within a few nanoseconds. These results were sent to Motorola, the receiver firmware was updated and reloaded into the receivers, and testing resumed.

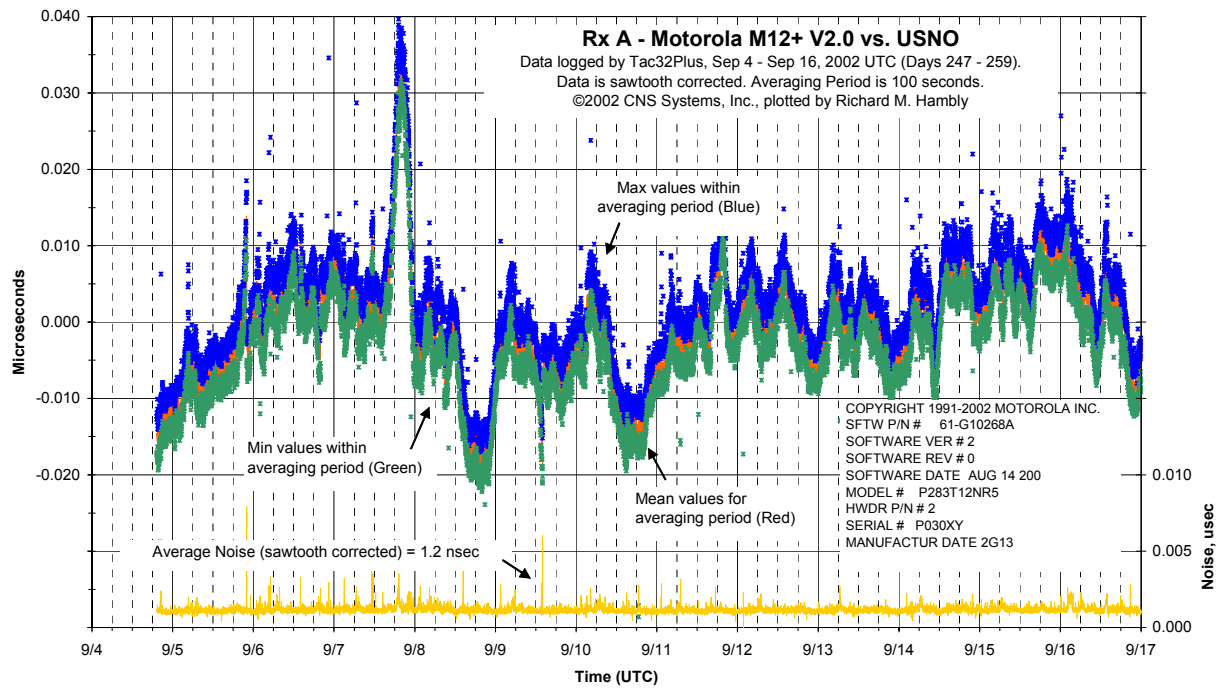
Figure 4. Post-calibration results.

Once the receivers had their revised firmware, the tests were repeated. This time the receivers were each very close to zero offset relative to UTC. The receiver shown in Figure 4 averaged 0.2 nanoseconds early over the more than 12-day period shown.

Notice the unusual excursion late on 7 September followed by two rebounds over the next 3 days. It turns out that during this period, Dr. Thomas A. Clark was photographing the night sky in Howard County Maryland (approximately N39° W79°) with his Cannon D60 digital camera. He captured a fairly rare and spectacular red and green aurora borealis display that commenced immediately after the peak shown on the chart. Additional data were collected and analyzed through mid-November with no repeats of either unusual data excursions or aurora displays

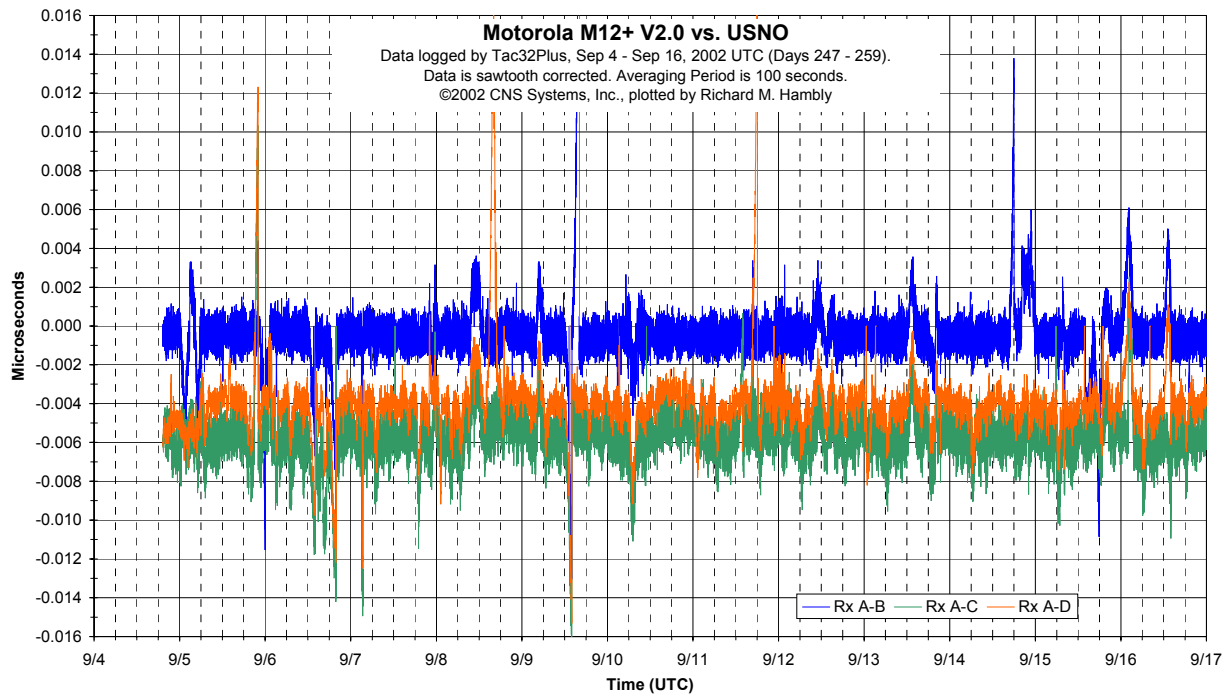
Figure 5. Result tracking - four receivers.

Figure 5 shows the tracking of the four receivers referenced to the “A” receiver. The “B” receiver tracks almost perfectly, while the “C” and “D” receivers are late by about 5 nanoseconds. This has been traced to a variation in group delay for the M12+ IF filters that came from two different production lots. It is hoped that the specifications will be tightened on these filters to minimize this offset in the future.

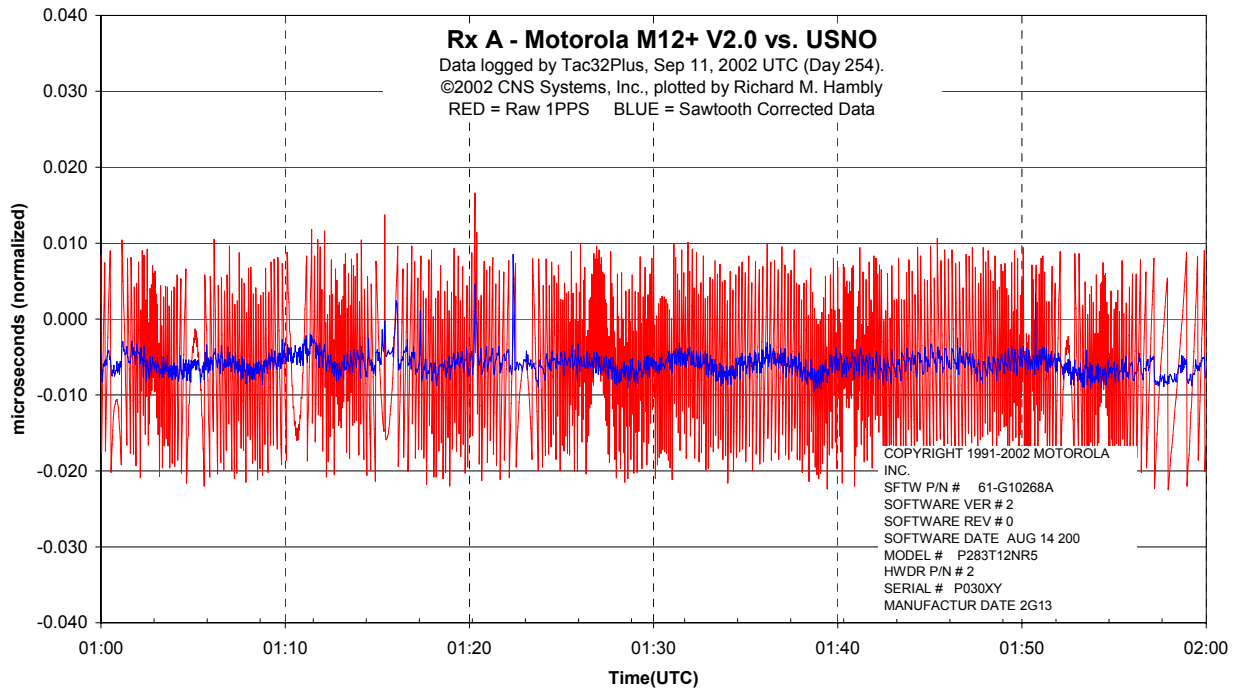
Figure 6. Short-term 1PPS noise.

The 1-hour short-term 1PPS noise for the post-calibrated M12+ Timing receiver is shown in Figure 6. The raw 1PPS shows the expected noise dominated by the quantization of the samples at twice the clock frequency of 16.367 MHz.

$$\frac{1}{2 \cdot 16.367 \cdot 10^6} = 30.55 \text{ ns } pk - pk$$

The line down the center of the short-term noise chart shows the effect of applying the sawtooth correction factor provided each second by the M12+ receiver to the raw data provided by the time interval counter. This allows for real-time correction of the quantization error and reduces the residual noise to about 5 nanoseconds peak to peak (pk-pk).

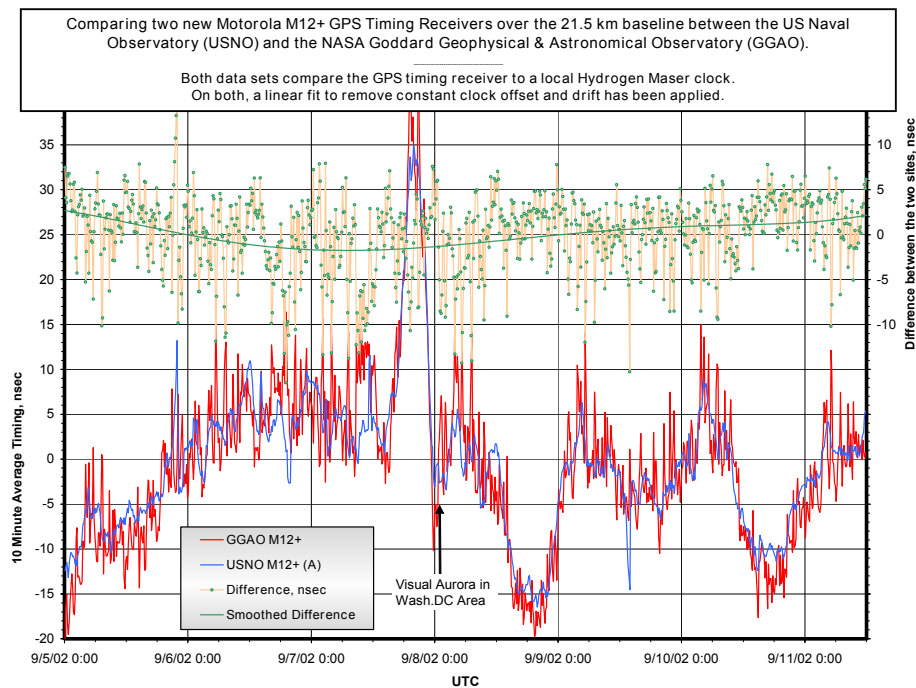
Figure 7. 21.5 km baseline test.

Many timing applications are more concerned by the degree to which two isolated timing receivers keep the same time. During the same period shown in Figure 4, a similar M12+ was being used at the NASA GGAO VLBI site, 21.5 km from USNO. Since both sites employed a hydrogen maser clock as their fundamental timing reference, we had an opportunity to test the differential timing performance of two separated M12+ receivers.

The results of this test are shown in Figure 7, comparing the performance of the “A” receiver at USNO (blue) with GGAO (red). The ~1.2 μs “DC” offset at USNO and a small (< 1:1014) linear drift have been removed from the USNO data. Similarly, a ~6.8 μs “DC” and ~1:1013 rate offset have been removed from the GGAO data. Because of differences in the data acquisition at the two sites (100-second samples at USNO, 60 seconds at GGAO), the raw data have been smoothed to yield common 5-minute samples. Clearly, the two data sets are in close agreement, even during the ~40 ns transient associated with the 8 September solar event.

Figure 7 also shows the point-by-point timing differences between the two sites. The rms difference between the two sites is 4.2 ns, while the absolute peak-to-peak range is 30 ns. A part of this is like due to small (< 1 ns/day/day) rate changes between the underlying hydrogen maser “flywheels.”
